Manhole Inspection Summary

Manhole # S33C__065MH

Insp Date: 11/11/08 12:50 PM

Location Address: **232 w liberty st**

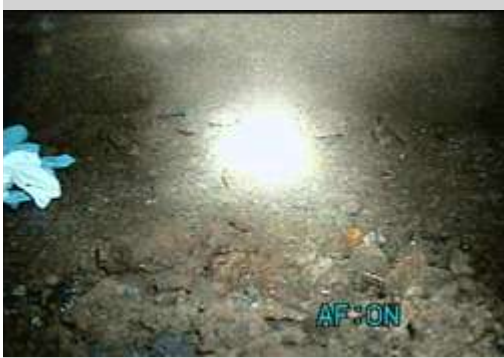
Defect 2

Condition: ☐ Sound ☐ Cracked ☐ Root Intrusion ☐ Deteriorated ☐ Leaks ☒ **Debris**

channel debris

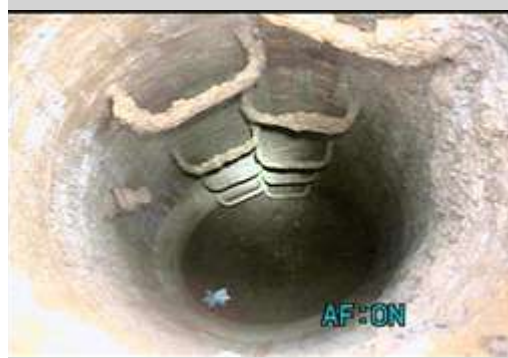
Defect 1

Infiltration: ☐ None ☒ **Joint** ☐ Cracks ☐ Mortar ☐ Roots ☐ Wall

Count: **9** Missing: **0** ☒ **Corroded**

corroded steps; signs of infiltration from corbel joint

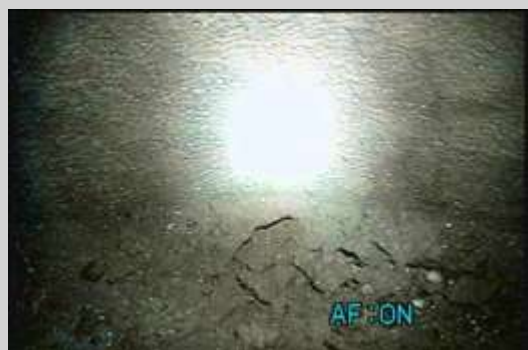
12 O'Clock Outflow

10 in. Circular Gravity Sewer
Pipe Out @ 12 O'Clock

Deposits: ☐ None ☐ Mud ☐ Sludge ☒ **Debris** ☐ Grease

Silt Depth: 10 (in.) Deposits Extent: **Heavy**
